# PILLAR ROOFING

## TPO Retrofit Proposal

### Inspection Report:

The photos below were taken on **July 9th 2024**; Our team inspected the entire roof system including the interior perimeter areas. The following photos and captions will show are our findings:

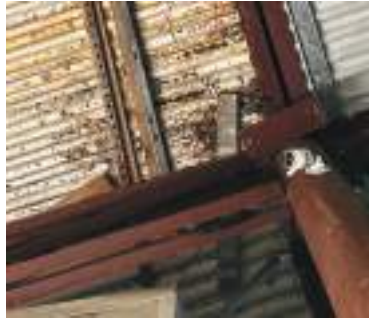
Emergency Roof Supports

**The photos above show:** interior damage to the buildings roof substrate and supports. The perimeter areas on this roof system are in full failure due to rainwater ponding along the perimeter areas. The excessive weight of the rainwater and two layers of Tar & Gravel roofing material has caused the substrate metal panels to break through in some areas.

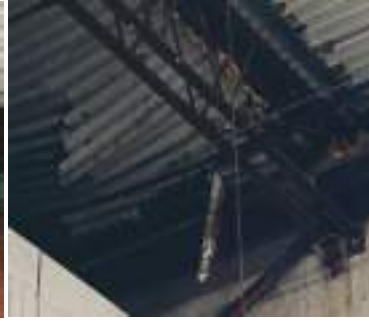
Severe Substrate Damage

This roof has a poor drainage system which has created perimeter moisture damage to the building's interior and exterior roof substrate. New metal substrate panels will need to be installed in several locations in order to regain structure integrity along the perimeter areas.

**Substrate Panel Repair:**

Several original substrate panel will to be removed and replaced in multiple locations, estimating the amount that will need to be replaced is not possible until we uncover the top later of existing roofing materials.

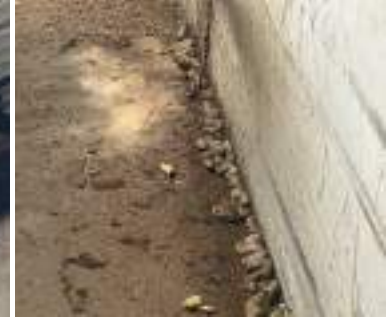
Persistent Interior Leaks

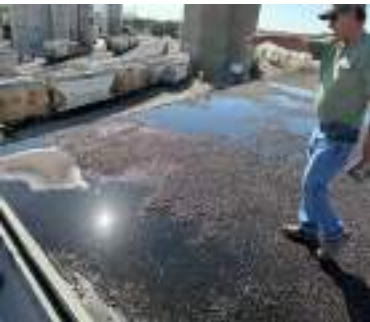
Perimeter Rainwater Ponding

**The photos above show:** Exterior roof damage along the perimeter areas. This roof has 2 layers installed, each layer of roofing material was installed with new metal edge details, the last time the roof was recovered the metal edge detail was install to high creating a low spots where the rainwater can not reach the gutter system.

- New metal roof edge details will be custom made to fit properly allowing maximum waterflow off the roof.
- A Tapered ISO package will be installed around the perimeter to ensure water flows over the side and into the new gutter runs.
- Custom fabricate and install new sheet metal gutter system including new downspout.

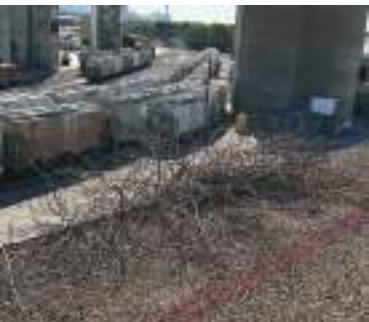
Gutter Clog

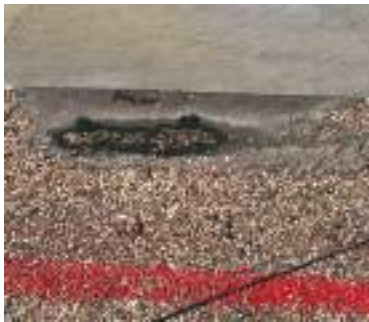
Perimeter Failure

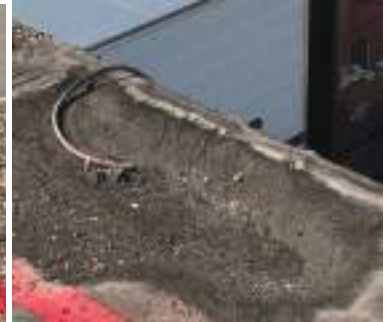
Metal Edge Detail Height Issue

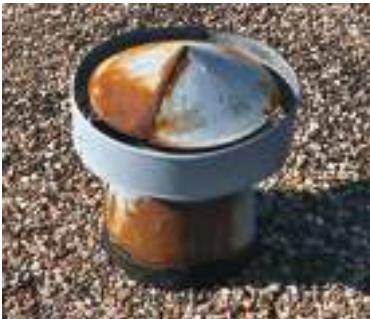
Rust Damaged Roof Fixture

**The photos here show:** The roof fixtures have been repaired in the past with some type of coating materials. Some of the repairs are starting to dry out and crack open allowing moisture to get under membrane and start the rusting process on the substrate.

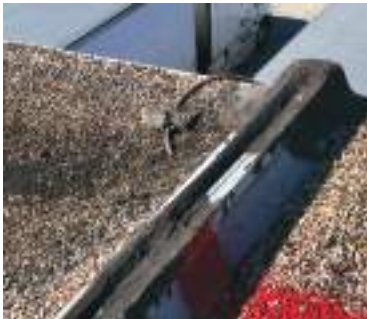
Expansion Joint Repairs

- New TPO flashing details will be installed on the A/C & skylight curbs, roof hatch and roof fixtures.
- Expansion joints will be reflashed with TPO membrane mechanically attached and fully adhered, as needed.

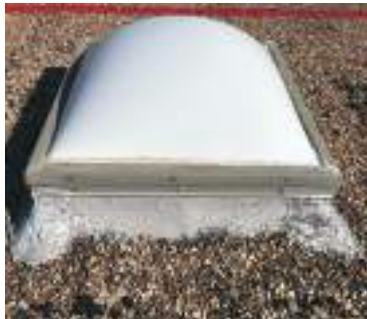
Skylight Curb Repairs

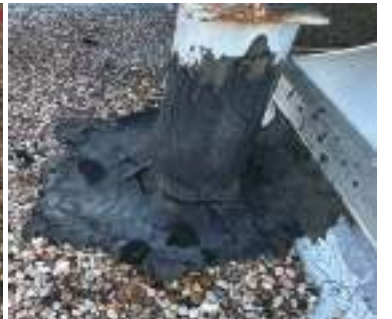
A/C Footer Penetration Repairs

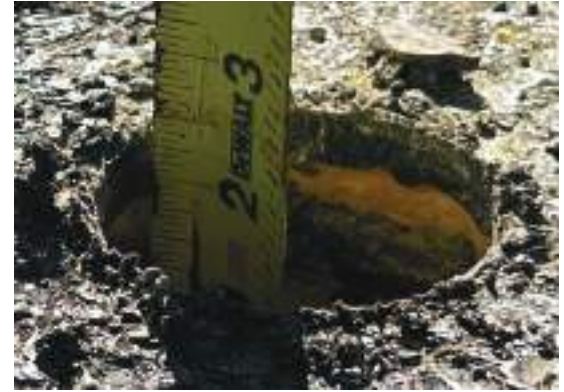
Approx. roof material depth is 2.5 inches

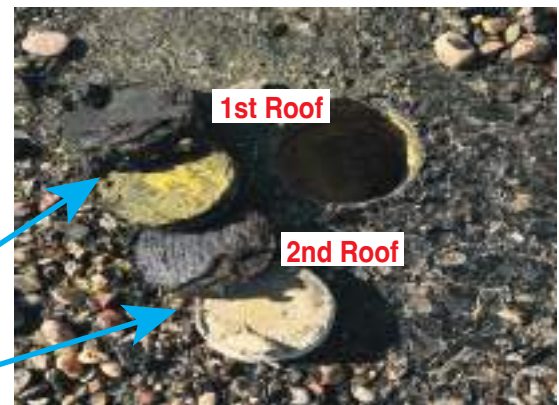
Photos show core-cut results

This photo shows 4 pieces we found from our core-cut.

The Yellow is the 1st layer of insulation when the building was roofed. The White pieces are the 2nd layer of insulation from the last re-roof.

The Black pieces are the top layers of asphalt sheets and the tar & gravel covering for each time it was roofed.
