Hybrid Built Up Roof Proposal

| Company Name: | Pillar Roofing EDPM Replacement | Date: | 04/18/24 |
| Project Address: | 1750 N. Collins Blvd. | Building #: | |

Inspection Report:

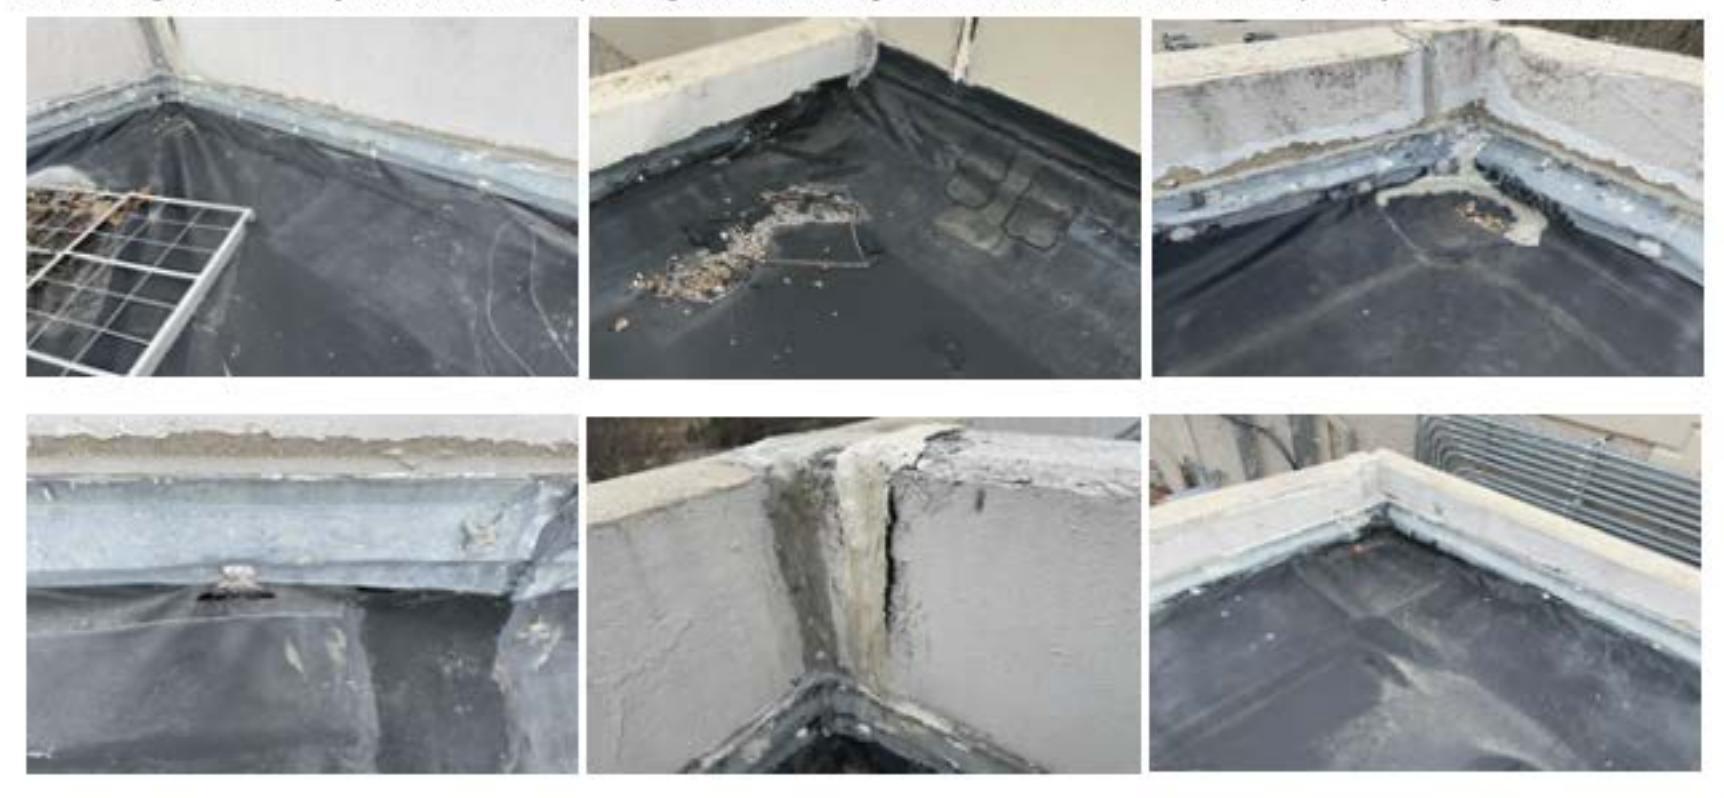
Perimeter & Parapet Wall:

The photos below show the EPDM membrane is pulling away from the termination flashing bar which is attaching it to the parapet wall. This damage is caused by the membrane expanding and contracting in the extreme heat and cold, especially freezing weather.

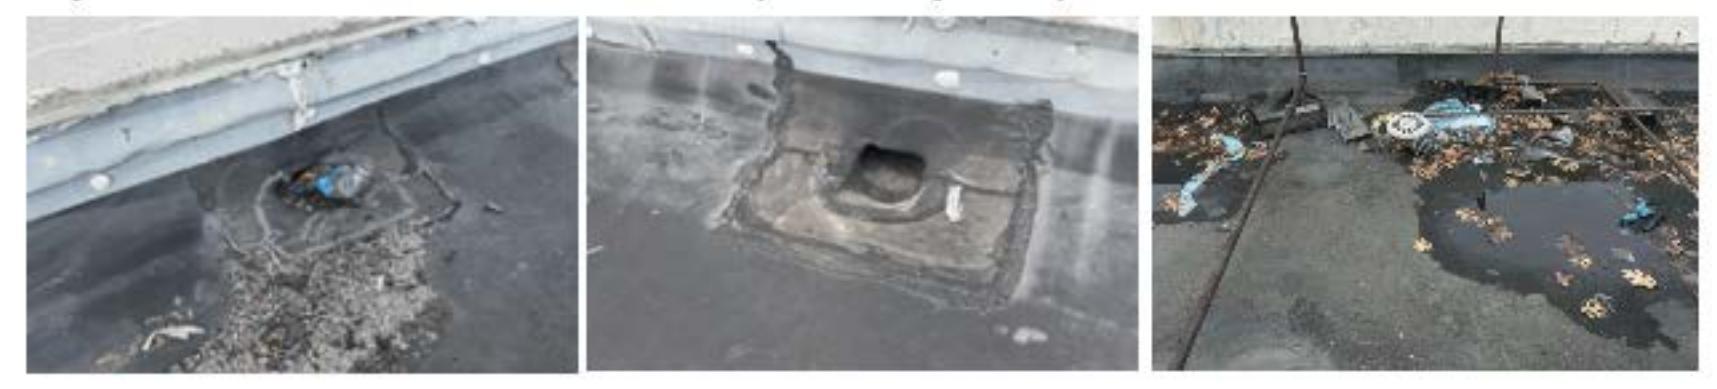
Roof drainage:

The photos below show how the scupper drains are also pulling away from the parapet wall flashing. These scupper drains are designed to take on the overflow rainwater when the roof system is taking on heavy rain and is overwhelmed.

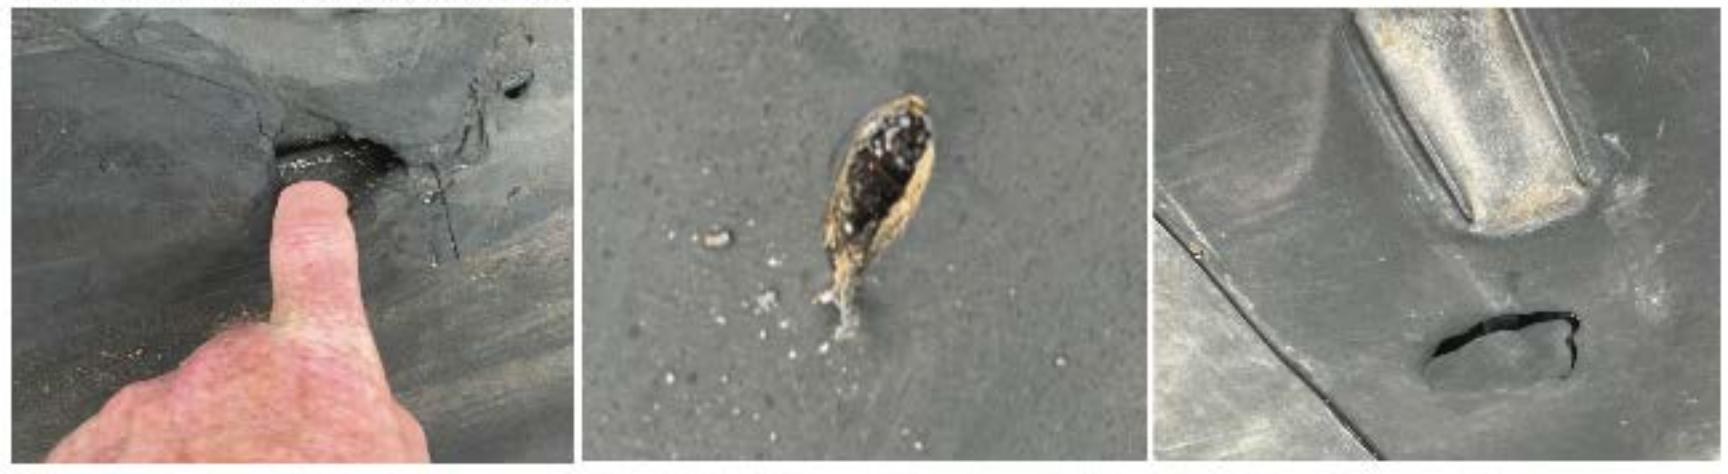
Membrane Condition:

The photo's below show the field area of the EPDM membrane has many punctures. Some of these holes go down deep beyond the roof insulation and on to the metal substrate.

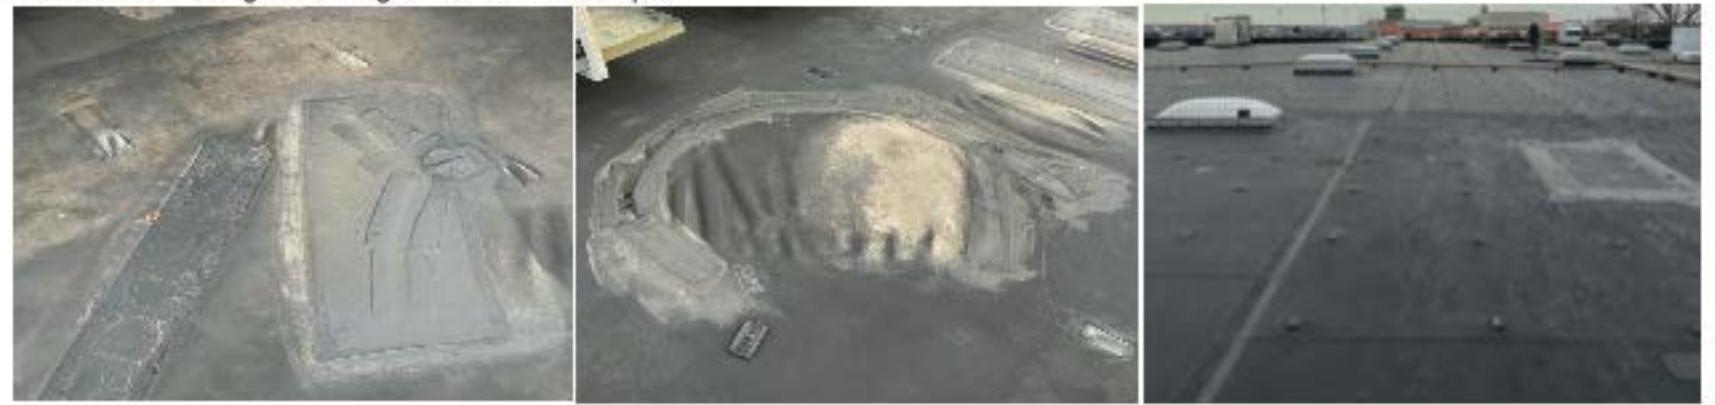
Membrane Cleat Attachments:

The photos below show the EPDM membrane is attached to the substrate with plastic cleats and hardware. We noticed a lot of these cleats were missing or coming loose from their clips.

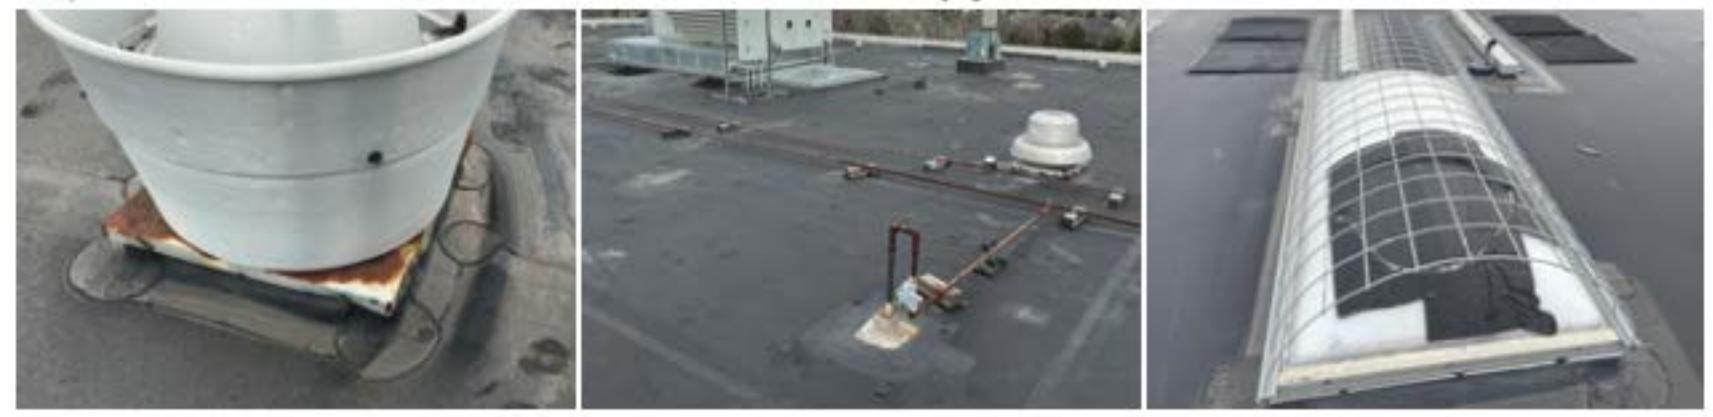
Roof Fixtures & Skylights Curbs: The photos below show some of the curbs around the roof fixtures and skylights are in need of attention around the base areas.

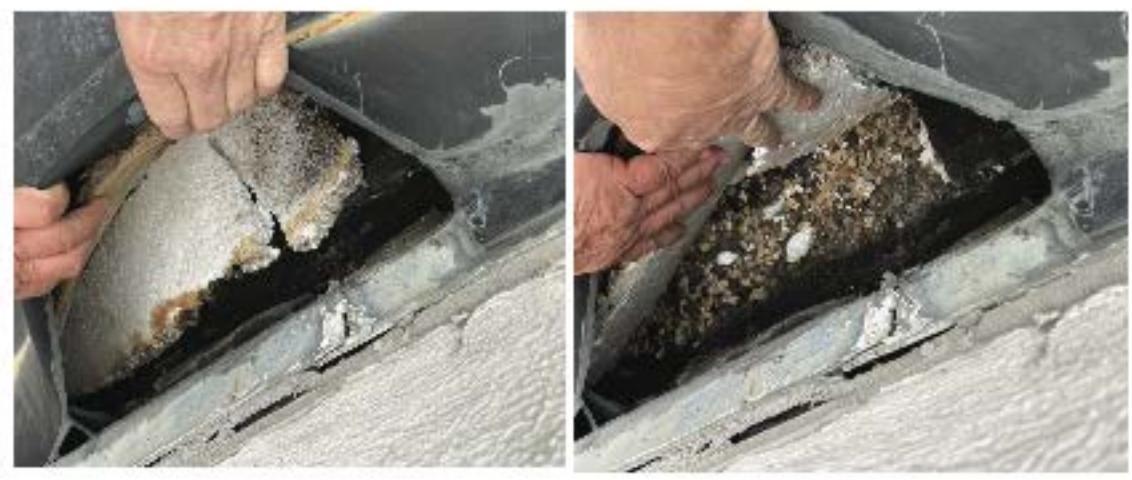
2nd Layer of BUR Tar & Gravel:

The photos on the right show there is a 2nd layer of built up roofing under the EPDM membrane system. This layer underneath with need to be remove in order to achieve the desired benefit.
