Company Name: **Pillar Roofing Commercial Services**

Project Address: **1750 N. Collins Blvd.**

City, State & Zip: **Richardson, Texas 75080**

Inspection Report:

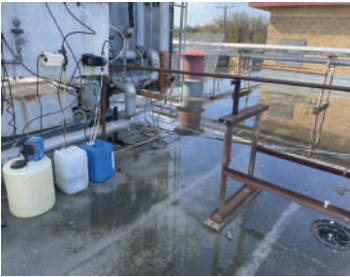
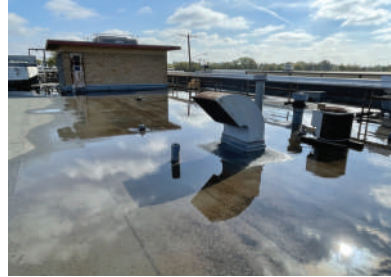
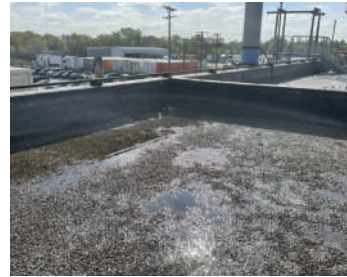
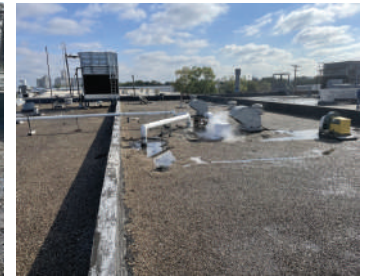
The photos directly below show both of these roof systems were inspected on **Nov. 15th 2022**. On that day both of these roof systems had a lot of water ponding on the surface and we were not able to get a close look at the drainage areas or take test core cuts.

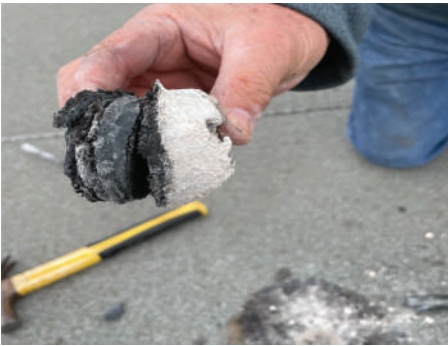
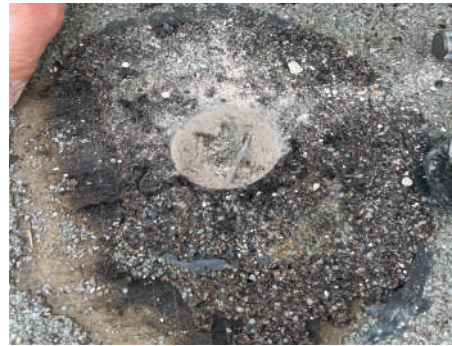
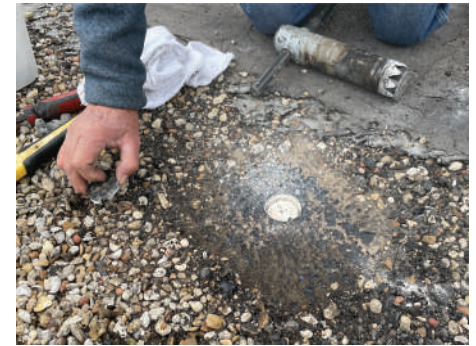
The photos below show: On our 2nd inspection on **Nov. 22th 2022** it was much drier and we were able to take our test core cuts.

The photos directly above show: both of these roof systems have a jipson lightweight construction material as a base substrate. You can see the white material in the photos, it looks like chalk and has heavy duty wire running through it for structural integrity. This means we can not use hardware to attach the the new roof system, it must be fully adhered with low rise foam adhesives.

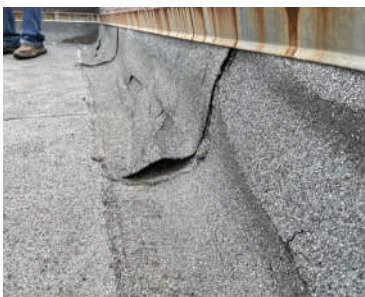
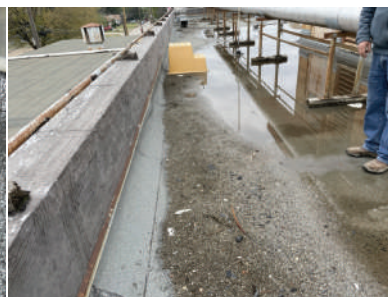
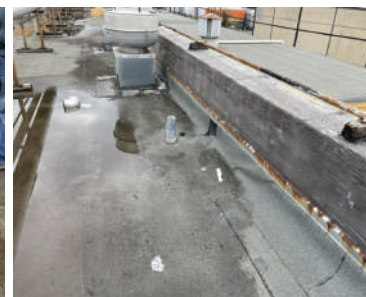
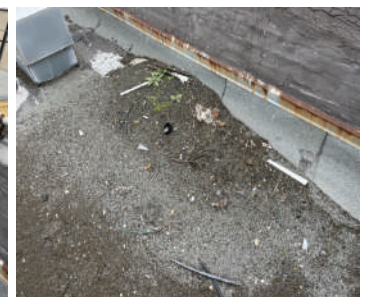
The photos above show: The parape wall area is stretching out of place and separating, leaving large openings for rain to enter the interior areas. The perimeter areas are full of debris and granules that have separated from the modified bitumen roof material. It's this debris that is causing most of the drainage issues.

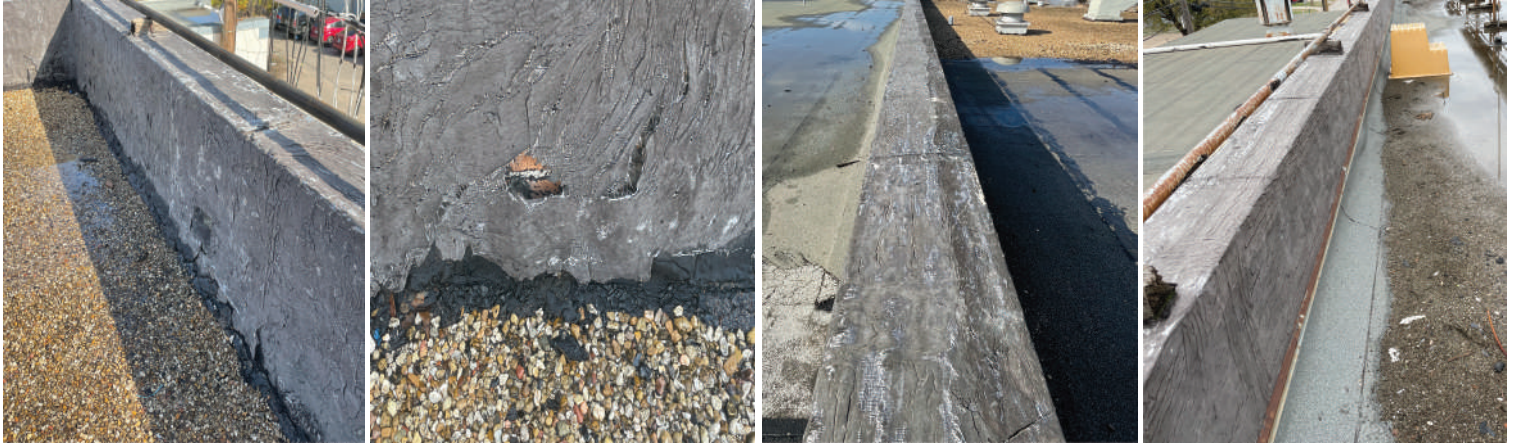
The photos below show: The asphalt materials that were used to seal the parapet wall areas are shredding apart and has become porous allowing rain to seep behind the parapet wall and eventually into the interior areas.

- The photos below show the steps needed to reseal the parapet walls around the entire perimeter areas with this TPO termination detail.
- Step 1: Install plywood with small shims creating a slight slope on the top area of the parapet wall; this will allow for run off.
- Step 2: Adhere shim and plywood into place along the top and in the counters of the parapet wall using low rise foam adhesives.
- Step 3: Mechanically attach the field TPO membrane to the side of the parapet wall as shown in the photo below.
- Step 4: Adhere the TPO membrane to the sides of the parapet wall and the plywood around the entire perimeter areas.
- Step 5: Form fit the TPO membrane sheet to the parapet as well as up and over the plywood, adhere in to place as needed.
- Step 6: Mechanically attach a 3 piece metal flashing assembly to the outside parapet walls, this is what will be seen from the ground.

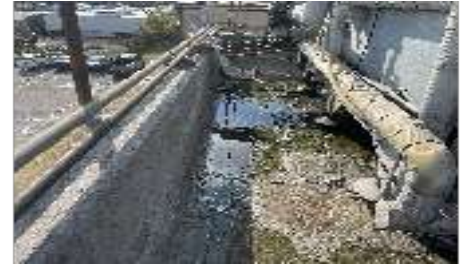
Problem 1: the ponding water on the modified bitumen section, the large A/C unit has a persistent leak that is part of the source.

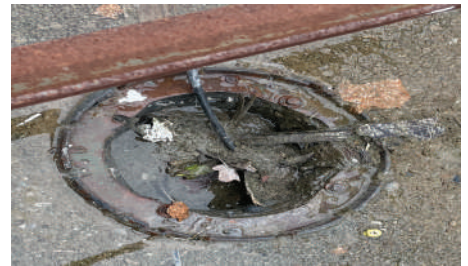
Problem 2: the drains on both sections of this roof system are clogged and needs a plumber to get them operational ASAP. These backed up roof drains allow water to hang around and saturate through the aged roofing material seams of the roofing

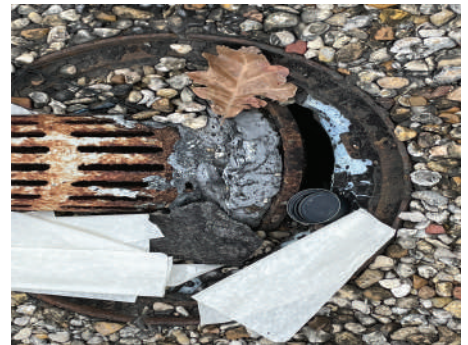
On the Tar & Gravel roof the drains are clogged with debris and gravel that has gotten past the drain caps. There are very few drains on these roof systems and most are clogged with debris and not allowing rain to move off the roof.

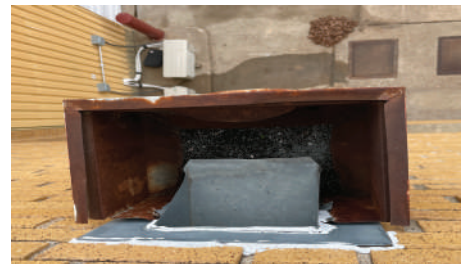
Problem 3: the gutter system is clogged as well and will need to be flushed out and cleaned of all debris so rain can drain off.

Some scupper downspout drains are also clogged. These overflow drains are where the rain water is supposed to run down through and then off property to the street.

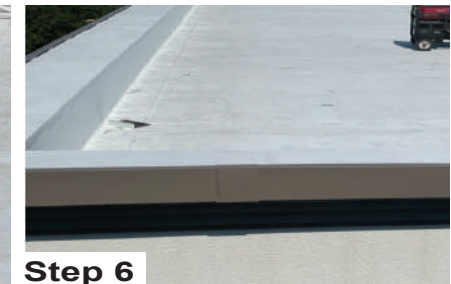
Step 6

This parapet wall detail is typical for all perimeter TPO membrane termination points of phase 1 & 2.
