# Pillar Roofing TPO Retrofit Restoration Project Completed December 2021

## Ben E. Keith Headquarters Downtown Fort Worth, Texas

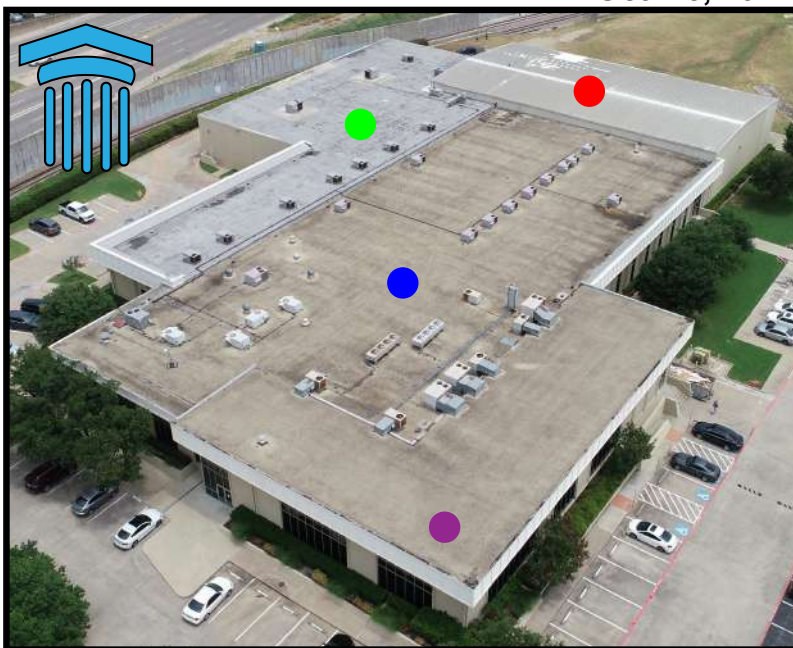
**Before**

**Phase 1:** 1980's: Metal Standing Seam ●  
**Butler Standing Seam 24 Gage Metal Panel Roofing System**  
*The Warehouse had Rust eating it's way through the metal panels creating water damage to the interior.*

**Phase 2:** 1990's: 4-Ply Build-Up Flat Roof ●  
**Built-up layers of Insulation, Rolled Cloth, and Silver Coating**  
*This area had roof leaks creating water damage to the interior.*

**Phase 3:** 1980's: Flat Roof Tar and Gravel ●  
**Concrete substrate with Tapered Insulation topped off with Tar & Gravel**  
*This area had roof leaks creating water damage to the interior.*

**Phase 4:** 1980's: Flat Roof Tar and Gravel ●  
**Concrete substrate with Tapered Insulation topped off with Tar & Gravel**  
*This area had roof leaks creating water damage to the interior.*

**Phase 1:** Metal Standing Seam Restoration ●  
Rusted areas were cut out and covered with new pieces of metal to fit the existing panel. Rust inhibitor was applied, damaged areas were triple sealed, then the warehouse was completely coated by applying 2 to 3 gallons HydroShield per 100 sqft. over multiple passes.

**Phase 2:** 4-Ply Build-Up Flat Roof Restoration ●  
Carlisle 60-mil TPO was mechanically installed with washer plates and screws per manufacturer's specifications. All TPO seams were hot-air heat welded and the membrane was sealed under new metal edge coping to match the building's facade.

**Phase 3:** Flat Roof Tar and Gravel Restoration ●  
Carlisle 60-mil TPO was fully adhered with bonding agents and adhesive foam. All TPO seams were hot-air heat welded and the membrane was sealed under new metal edge coping to match the building's facade.

**Phase 4:** Flat Roof Tar and Gravel Restoration ●  
Carlisle 60-mil TPO was fully adhered with bonding agents and adhesive foam. All TPO seams were hot-air heat welded and the membrane was sealed under new metal edge coping to match the building's facade. Perimeter roof edges are double sealed to add more uplift-wind-shear protection.
