Modified Bitumen Roof Inspection

Project Address: **1750 N. Collins Blvd.**

Our inspection took place on **Feb. 26th 2025**. We inspected the modified bitumen membrane areas including: Membrane condition, A/C curbs, Perimeter, Drainage, and Maintenance needed. The photos taken will show our findings.

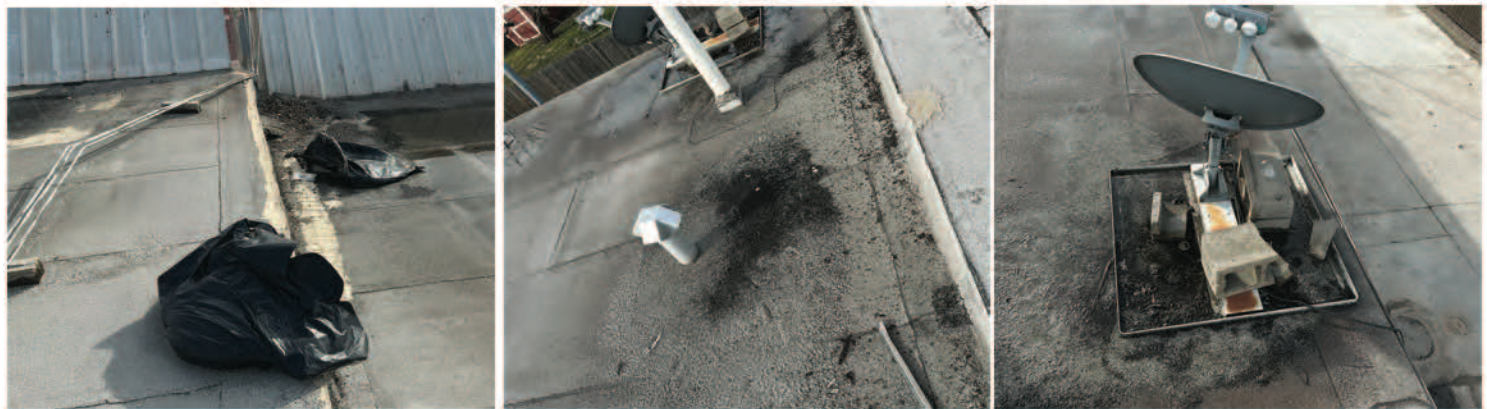
Roof Debris & Item For Removal:

The photo's above show debris that should be removed or relocated.

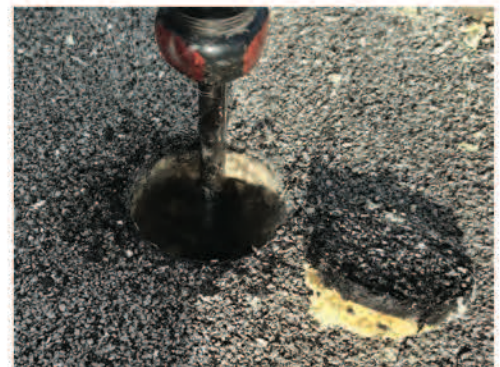
Roof System Core-Cut Results:

We found 1 layer of roofing materials, which means; City codes allow for commercial buildings to have up too 2 layers before needing a full removal.

Including the top layer of modified bitumen membrane this roof area has approx. 3.5 Inches of insulation and a metal substrate.

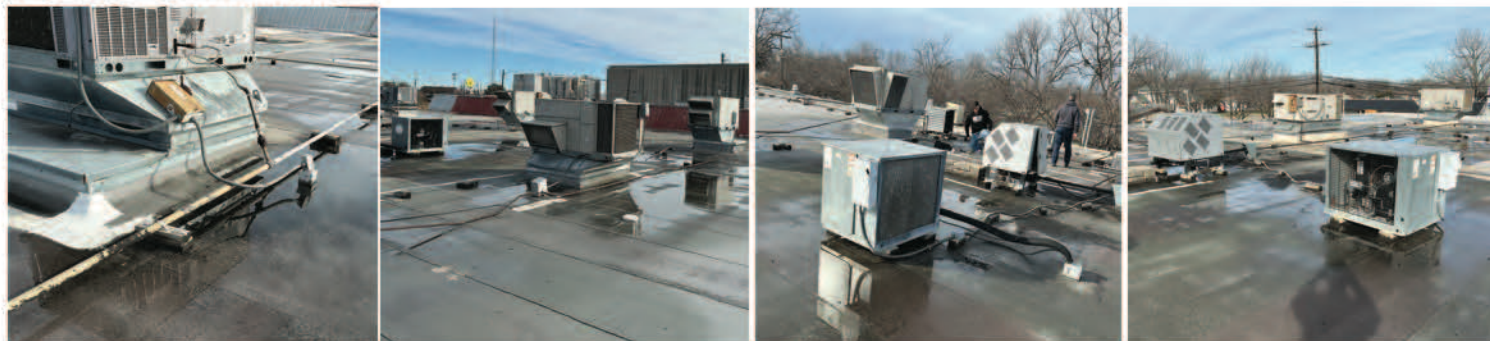
A/C Curbs & Pitch-Pans:

The photo's above show a lot of extra equipment has been installed on this roof area after the roof system was installed. The added weight to substrate has created low areas on the roof surface that are now holding ponding rainwater which is leaking into the buildings interior.

With all the extra weight from the added equipment new curb mounts with crickets and saddles should be installed for each unit. These new details around the curbs will create drainage flow off the roof.
