Hybrid Built Up Roof Proposal

| Company Name: | Pillar Roofing EDPM Replacement | Date: | 04/18/24 |
| Project Address: | 1750 N. Collins Blvd. | Building #: | |

Inspection Report:

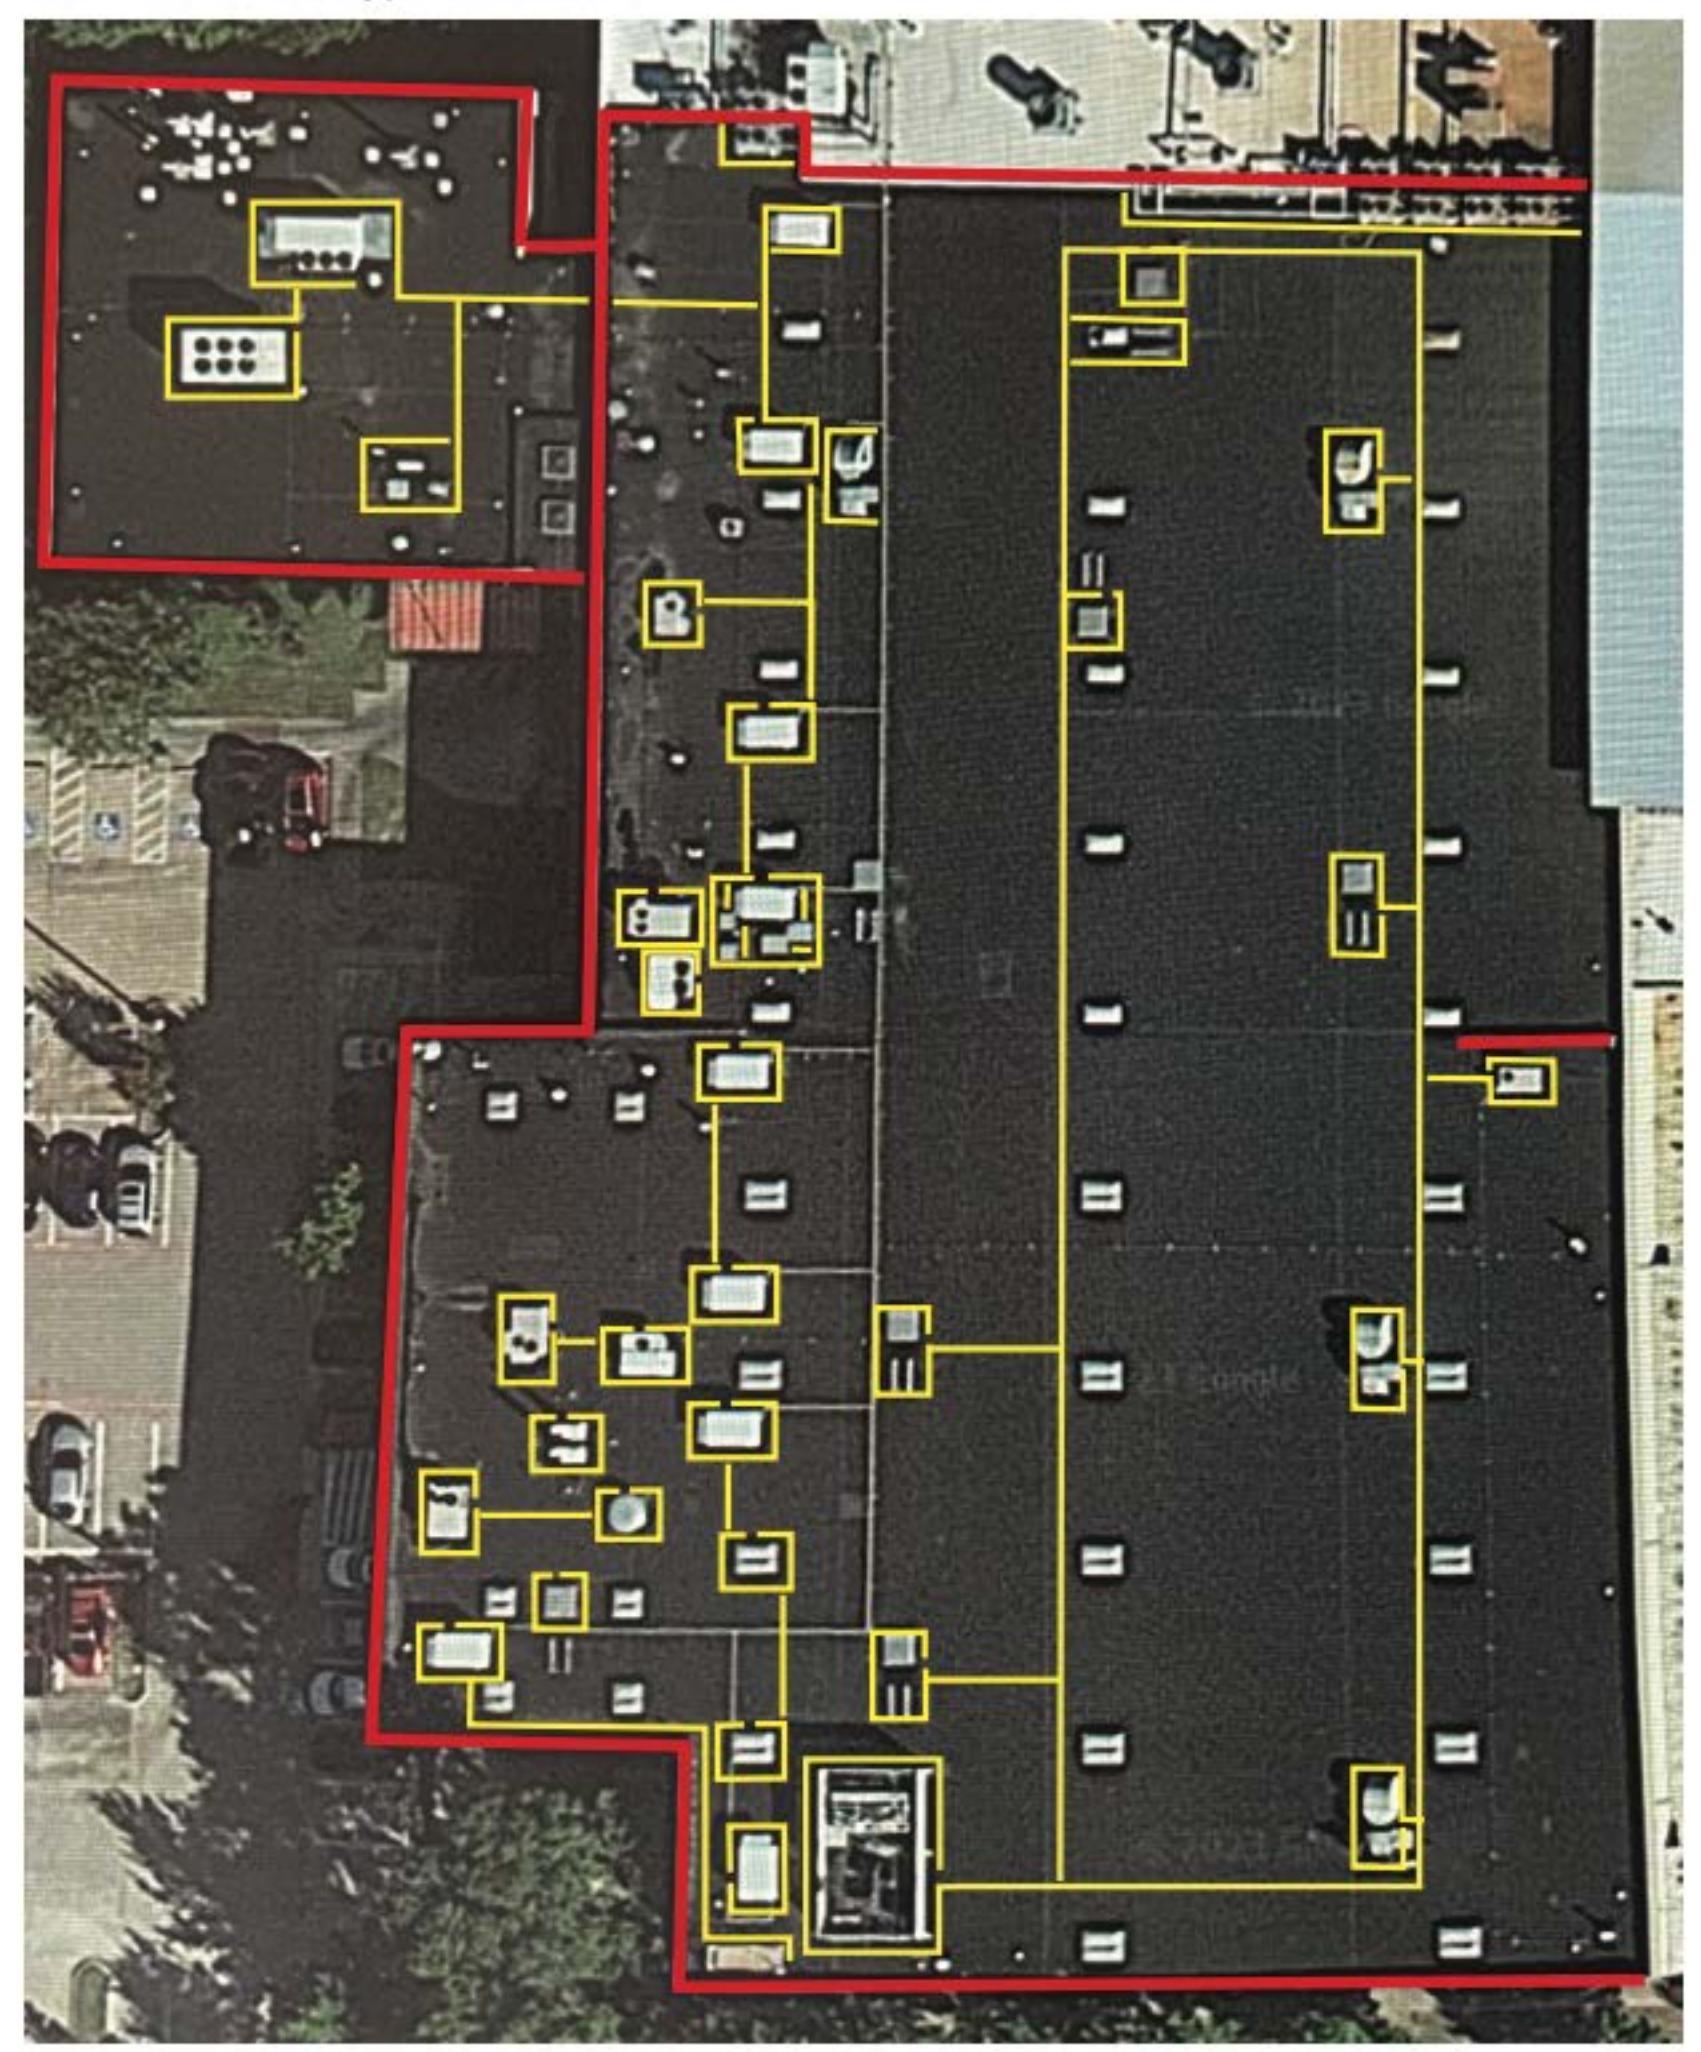
Parapet Wall & Safety Pad Track Details:

- · Red lines indicate parapet walls.
- · Yellow lines indicate Sately pad track locations.
