# PILLAR ROOFING

## Standing Seam Roof Inspection

### Inspection Report:

## Project Subject: Install a fully Coated ARC HydroShield Roof Maintenance System

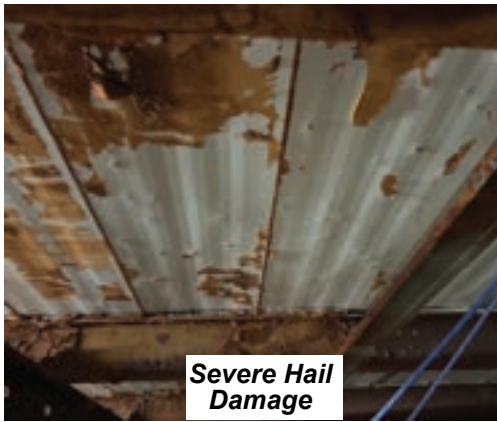
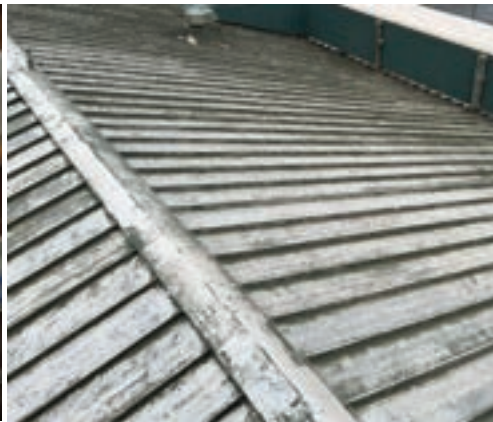
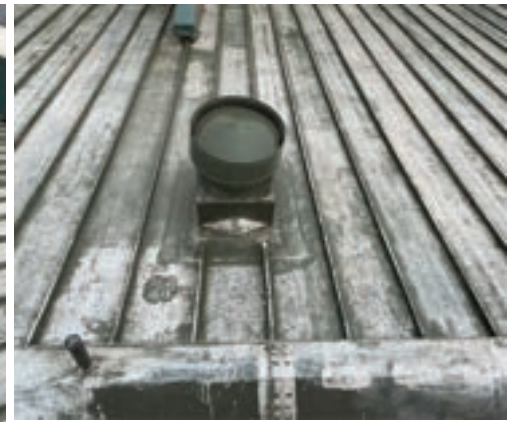
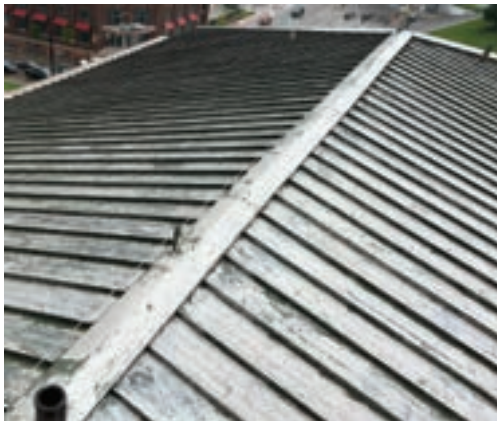
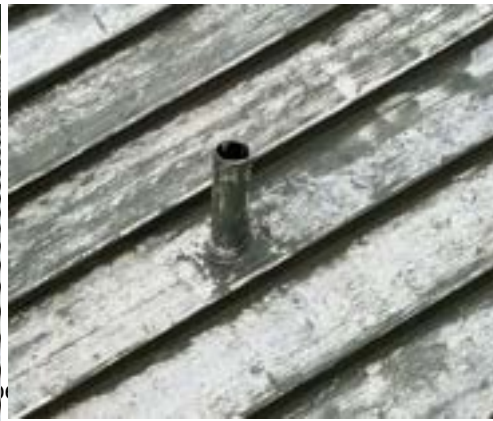
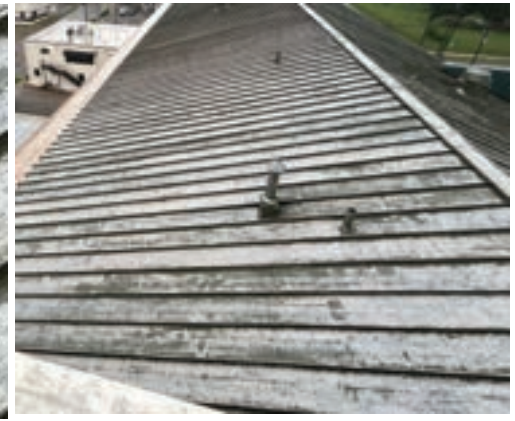
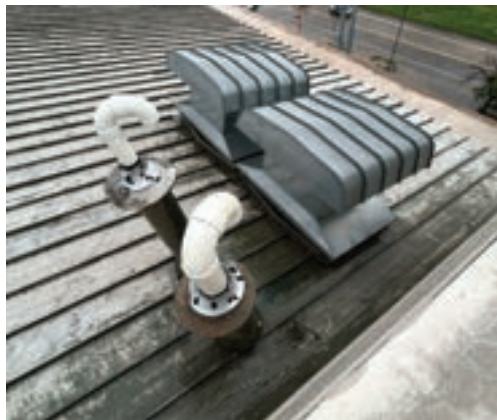
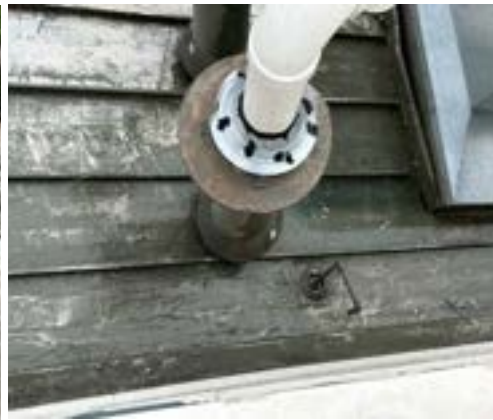
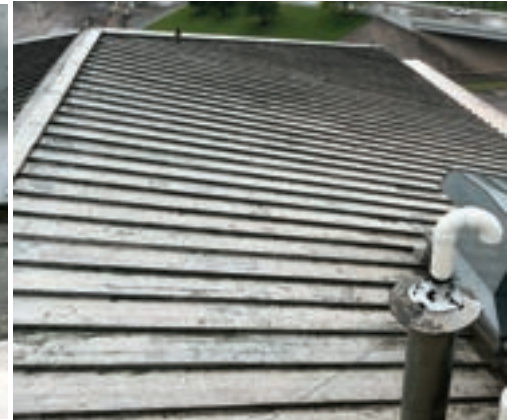
### Metal Roof Panel Condition:

Our inspection took place on **APR. 30th 2025**. We inspected the metal paneled roof system from the top and the attic areas. We found severe hail damage from a past storm that destroyed the metal panels factory paint finish. As a repair the panels were then painted using brushes and rollers. Some leaks were present at the time of our inspection. The photos taken will show our findings.

The roof coating paint materials that was used to cover and seal the damaged metal panels in full failure, leaking will persist.

- Clean and clear roof surface of dust, debris and as much of the damaged paint coating material as possible.

- All roof penetration flashings will be treated with ARC DynaShield seam sealer and wrapped polyester cloth applied with our **Triple-Sealed Process** over the entire roof system.

- TPO areas that transition to metal will be treated with ARC DynaShield seam sealer and wrapped polyester cloth applied with our **Triple-Sealed Process**.

- All metal panel terminate along the ridge cap line, these areas will be treated with ARC DynaShield seam sealer and wrapped polyester cloth applied with our **Triple-Sealed Process**.

- All roof panel fasteners will be treated with ARC DynaShield hardware sealer, applied with a special tool that covers the hex screws with a dab (Hershey's kiss like) of waterproofing.

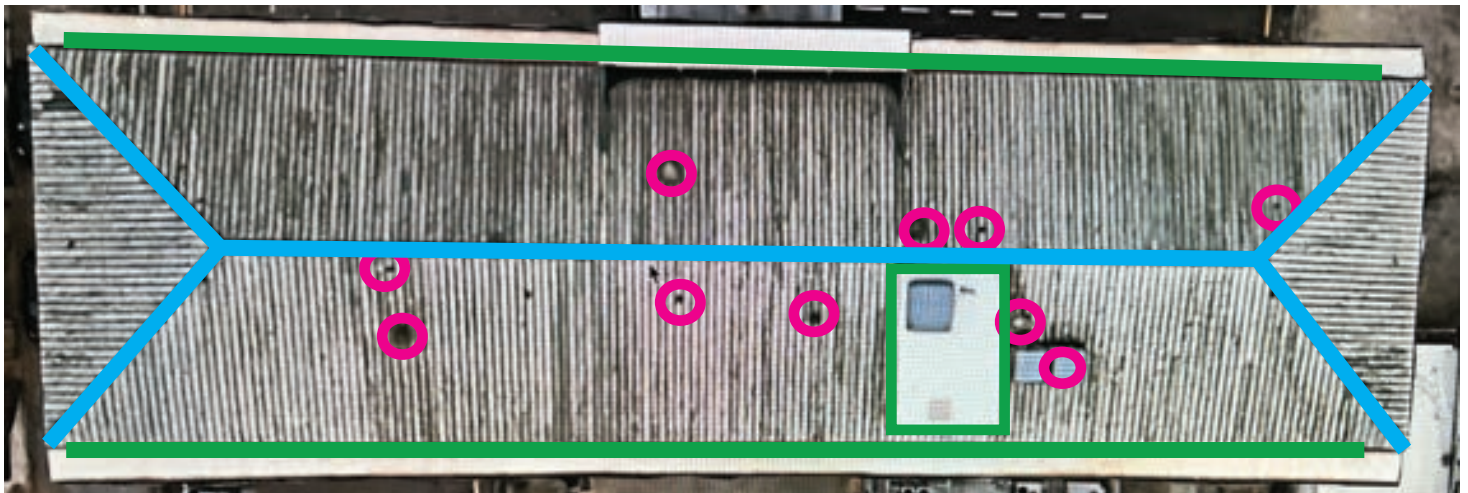
##### **Triple-Seal Process is applied to seal metal panel seams, and roof flashings**

1. Apply 1st layer of the base coat of DynaShield water proofing material
2. Apply 2nd layer of prep cut polyester bonding cloth over the top of the base coating.
3. Apply 3rd layer of DynaShield top coating to complete the **Triple-Seal Process**.

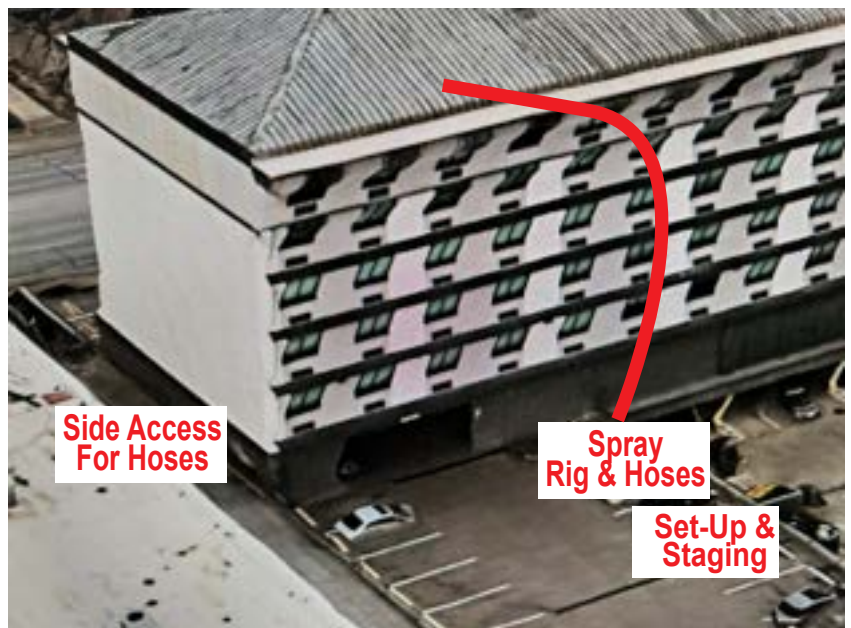
##### Spray Clear Sealer Finishing Coat:

- Spray apply a final coat of clear sealer that will help prevent dirt build up.
